CALIFORNIA DIVISION OF MINES AND GEOLOGY

FAULT EVALUATION REPORT FER-143

Kern Front, New Hope, and Premier Faults, Kern County

December 19, 1983

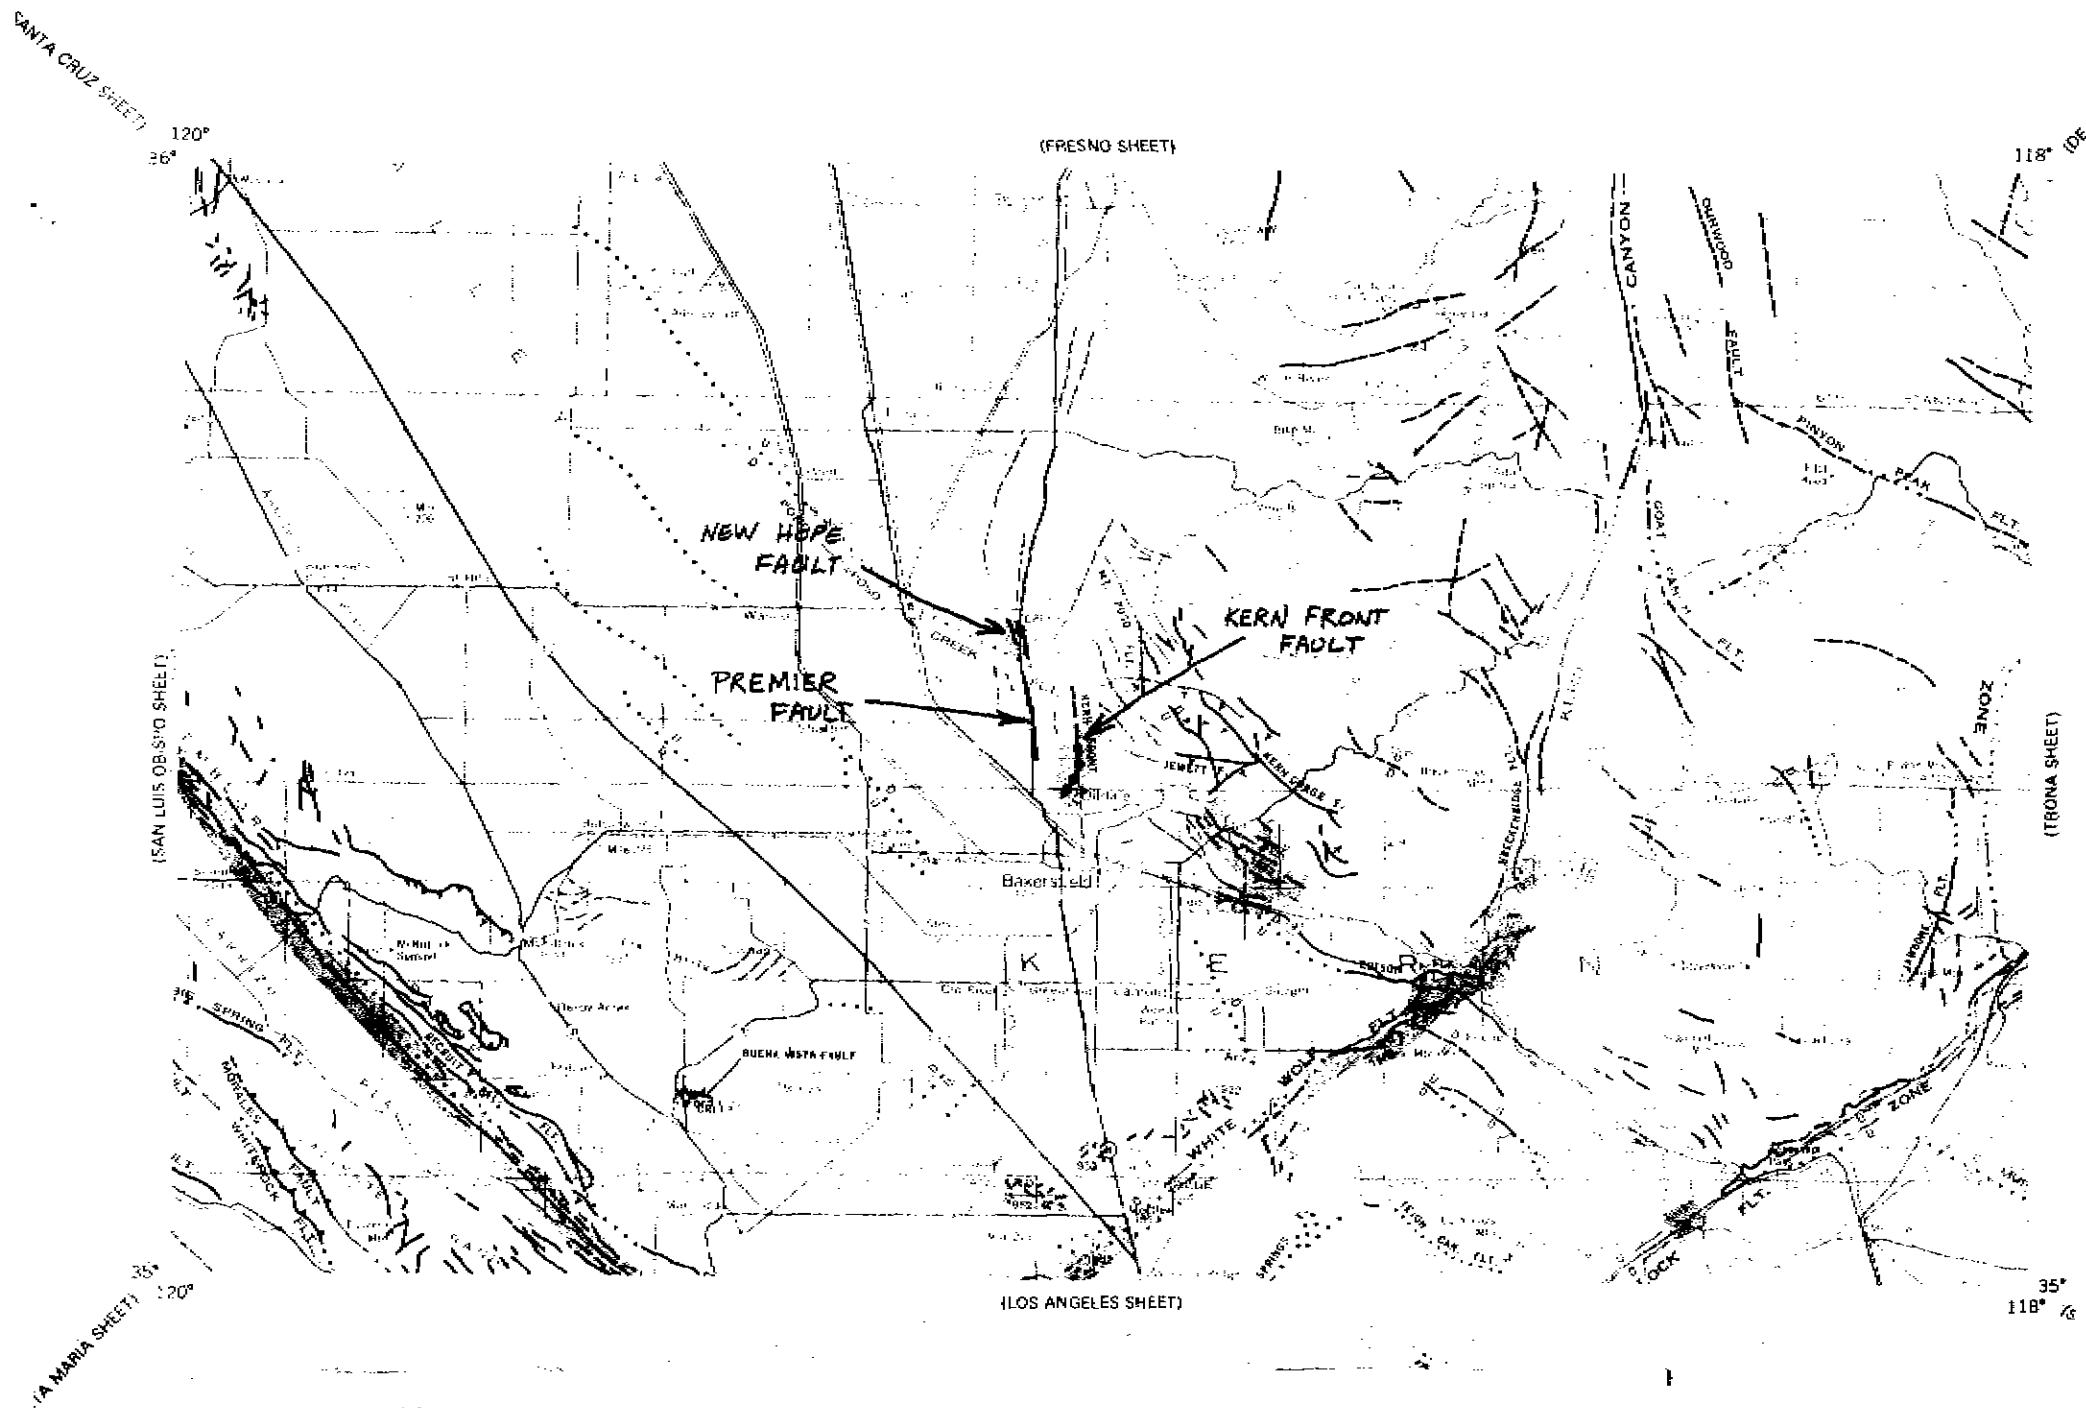
FER-143. Figure 1. Location of the Kern Front, Premier, and New Hope faults (after Jennings, 1975).

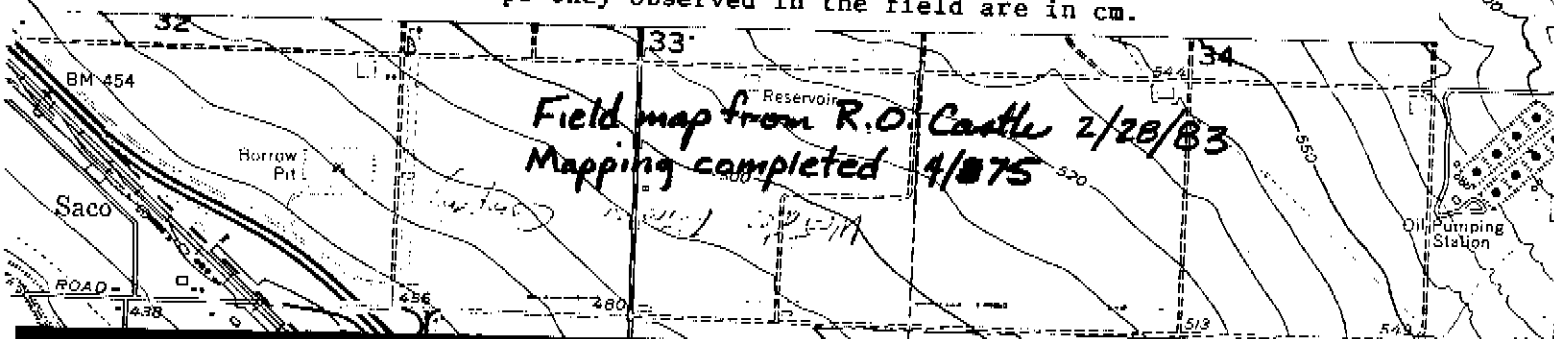
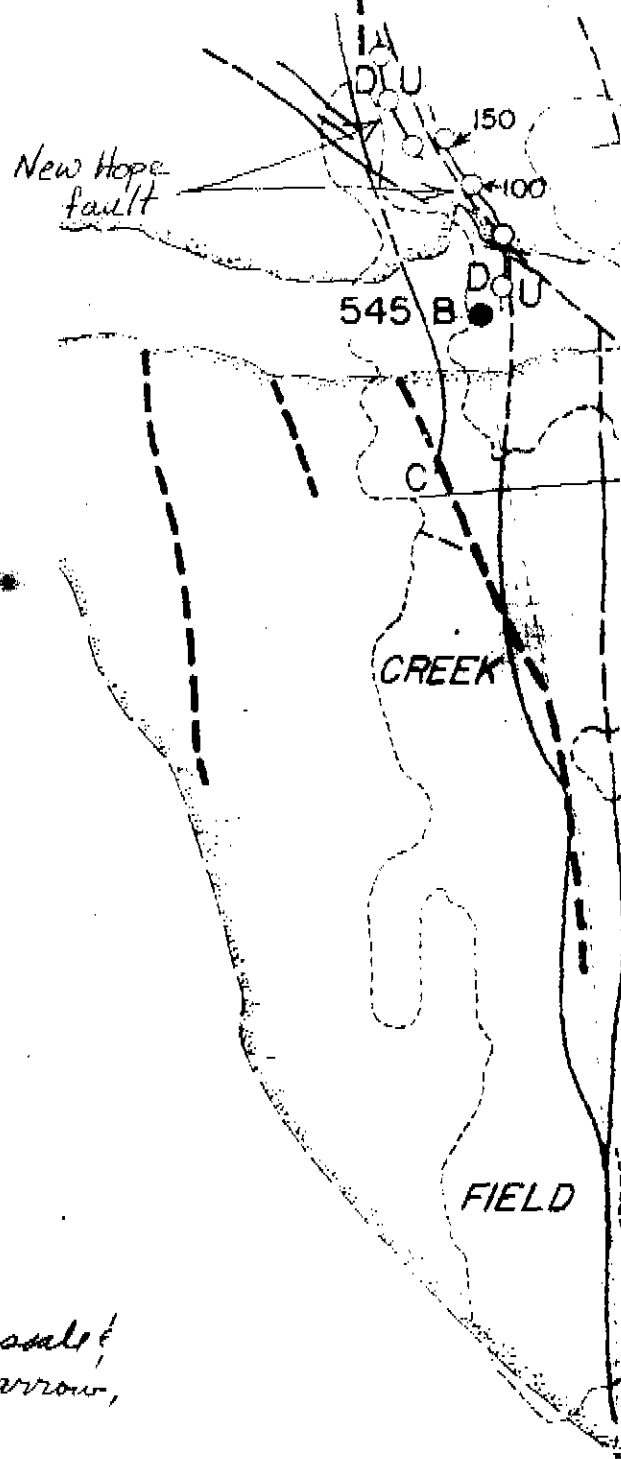
FER-143. Figure 3C. Portion of a map by Castle and others (in press). Creep localities along the New Hope fault indicated by open circles; scarp heights they observed in 1975 are given in mm.
